## Media communiqué

**Empa researchers discover why implant coatings detach – and a method to prevent it**

### **Nanocorrosion causes implants to fail**

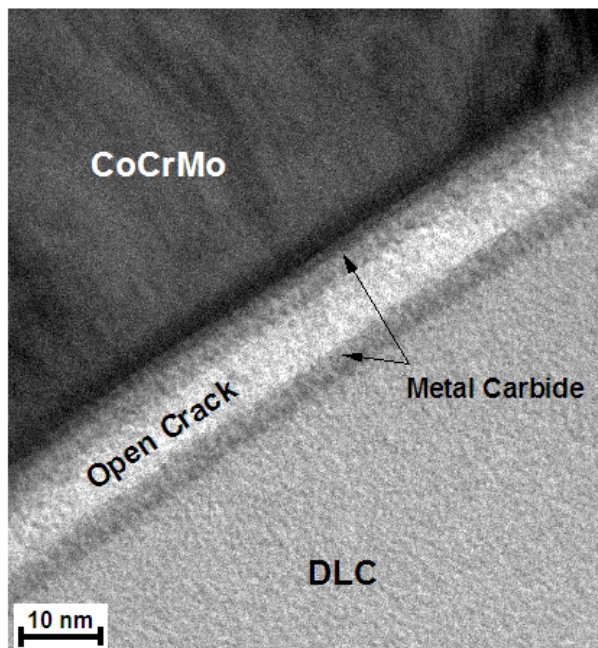
His team showed that the so far barely considered reaction layer, which is not always completely corrosion resistant, is responsible for the detachment of the DLC layer. On the one hand, stress corrosion cracking occurred in the reaction layer. The mechanical load in conjunction with the penetration of body fluids led to slow-growing cracks, which in turn caused the DLC substrate to detach little by little.

Under physiological conditions, stress corrosion cracking leads to a slow-growing crack in the metal carbide reaction layer, which is barely 5 nanometers wide. This, in turn, causes the DLC layer to detach from the implant material (cobalt-chrome-molybdenum, CoCrMo), as seen in a transmission electron microscope image.

But the Empa team didn't stop there; together with their industry partners Synthes and Ionbond, they developed a corrosion-resistant intermediate layer at the interface to the DLC layer. What's more, the researchers also developed a process that can determine a crack's growth rate under conditions similar to those experienced in the human body as well as the dissolution rate of the reaction layer in cases of crevice corrosion. "This then allows us to calculate the expected operating lifetime of the coated implant in the human body", says Roland Hauert. Whether or not a DLC-coated implant will fail prematurely *in vivo* can henceforth already be determined during the development of the product.
